TASKER MILLWARD SCHOOL

KEY FACTS

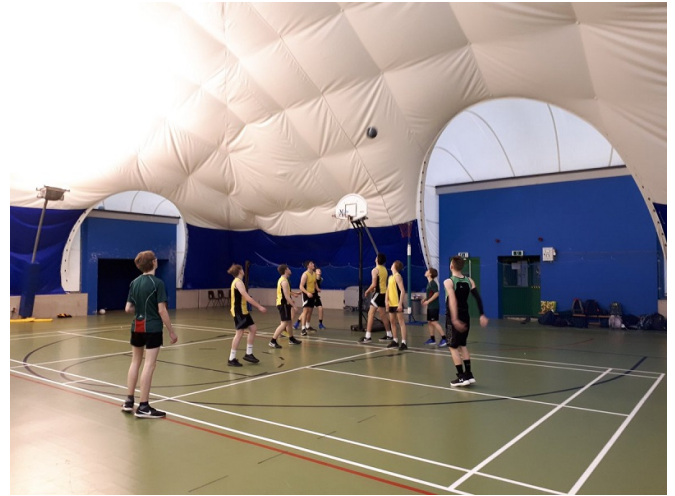
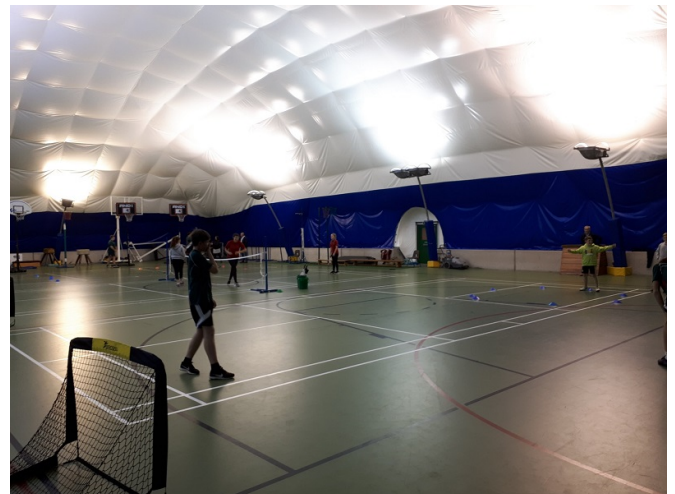
As a specialist contractor, J & J Carter were able to design, manufacture and install a sustainable replacement membrane within a short time frame. Starting with the site survey, J & J Carter took full design responsibility. Due to the sheer size of the dome, it was fabricated off-site in manageable sections with each section site jointed to its neighbouring section with a mechanical joint. The total weight of the membrane was 6.5 tonnes, which had to be inflated to the required pre-stress and form.

The outer dome fabric is a Type 3 PVC from [Mehler Technologies](#). The PVDF top lacquer gives excellent protection and makes for easier cleaning and maintenance. The inner lining is a Type 1 650gsm PVC from Mehler. The lower 3m is in a contrasting blue whilst the remainder is white which helps to reflect the light within.
